# **Periodic Dam Safety Inspection Report**

## **Little Falls Dam Little Falls Spillway Dam** Lincoln County, Washington

April 2004  
04-11-008

## ***Periodic Inspection Report***

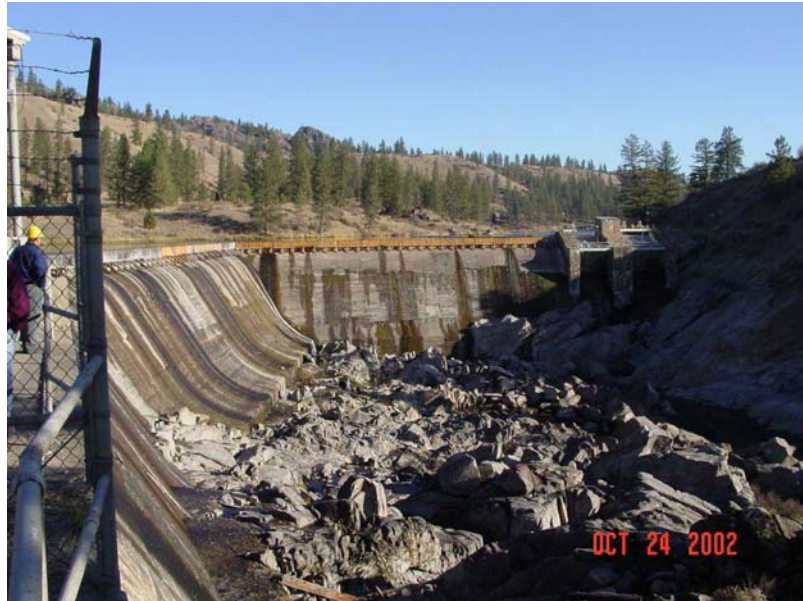
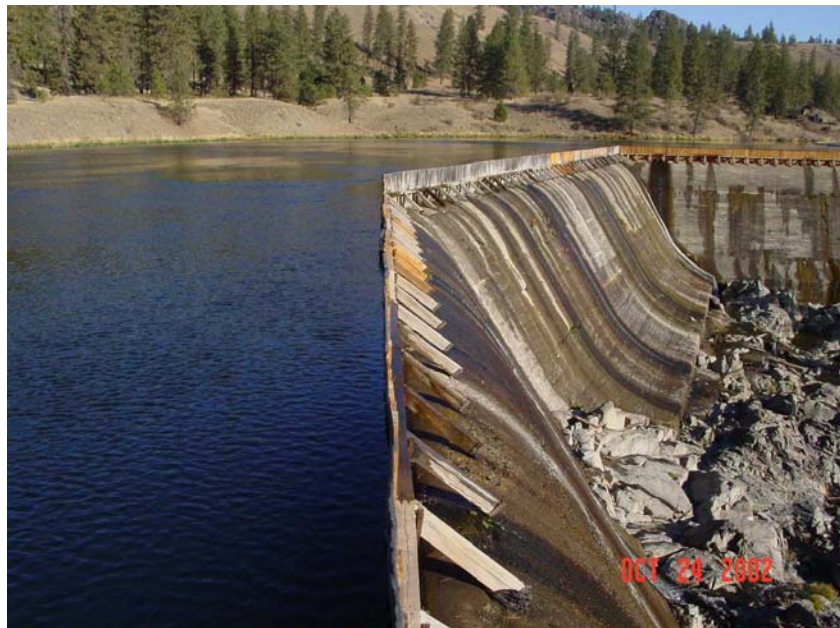
The concrete surface of the downstream face of the Spillway Dam is also variable. This is probably due to the cyclopean concrete construction method. Thin concrete cover between formwork and embedded granite boulders has probably spalled off, resulting in an exposed granite surface. This boulder surface is not smooth or flat and could be what gives rise to the surface appearance in some areas of the concrete dam.

The Spillway Dam crest has wooden flashboards installed that raise the pool 5 feet. A pivot mechanism with a release cable drops the flashboards. A pool level slightly above the base of the flashboards was being maintained at the time of our inspection. No attempt was made to inspect the flashboards or Spillway Dam overflow section, other than a visual observation from the Spillway Dam abutments. The use of temporary wooden flashboards does present some risk to public safety, since a sudden failure due to a reservoir surge (from the unit shutdown discussed above) could send a

Photo 1 & 2 – Spillway Dam, Downstream Face of Dam (Top)  
and Top of Flashboards (Bottom)

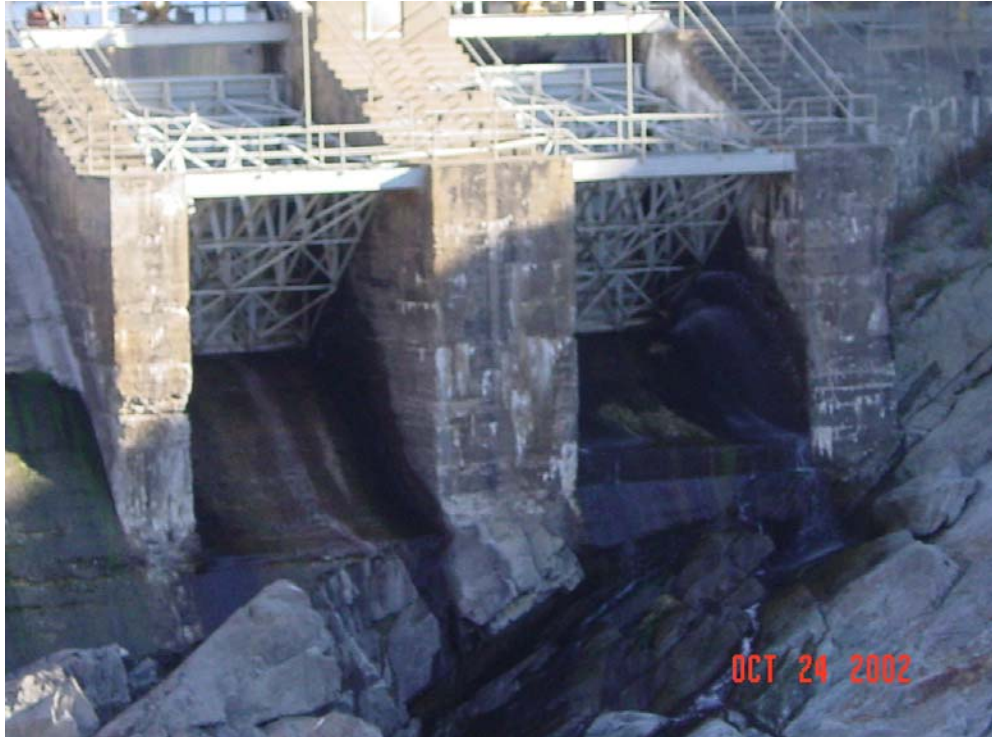
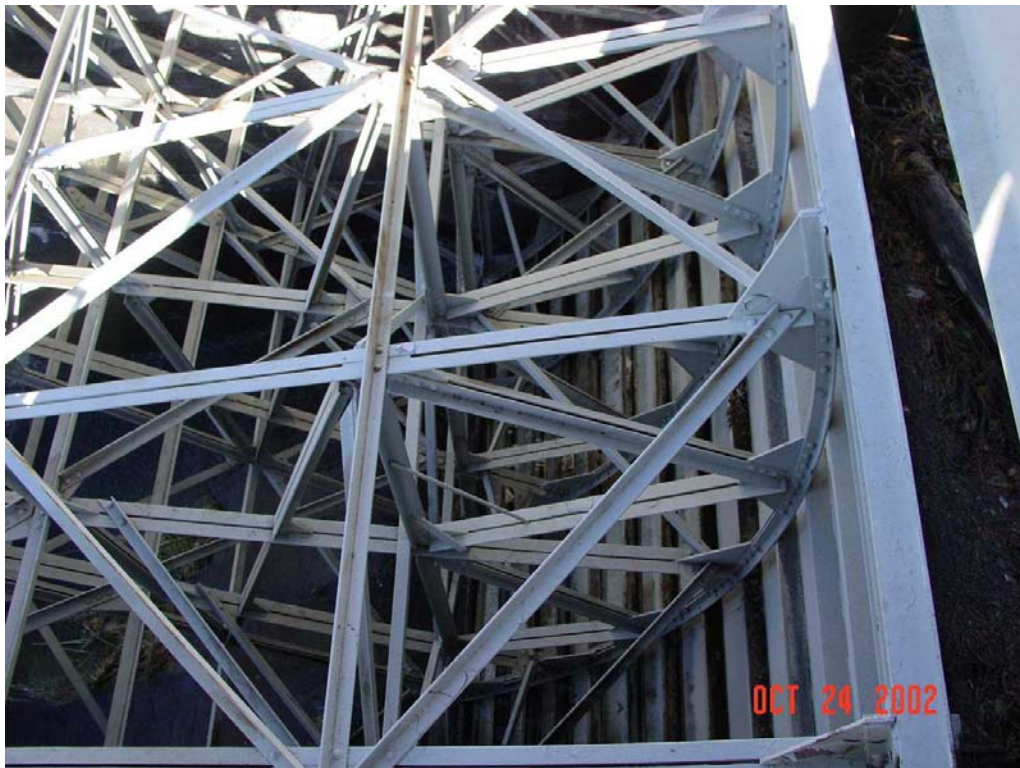
The Little Falls Dam has a gate structure at the left abutment of the dam. Mounted within this structure are two 24 x 20 foot tainter gates. During this inspection, the gate girder, steel struts, and gate hoists were inspected, but the gates themselves were not operated. The downstream view of the gates revealed no corrosion, bent struts, or obvious damage or misalignment of the gates. There was no vantage point where the upstream face of the gate skins could be inspected. According to Avista, the gates are opened annually and emergency power is available to the gates for opening purposes.

Photo 3 & 4 – Radial Gate Structure, Left End of Dam (Top)  
and Gate Structure & Downstream Face of Skin (Bottom)

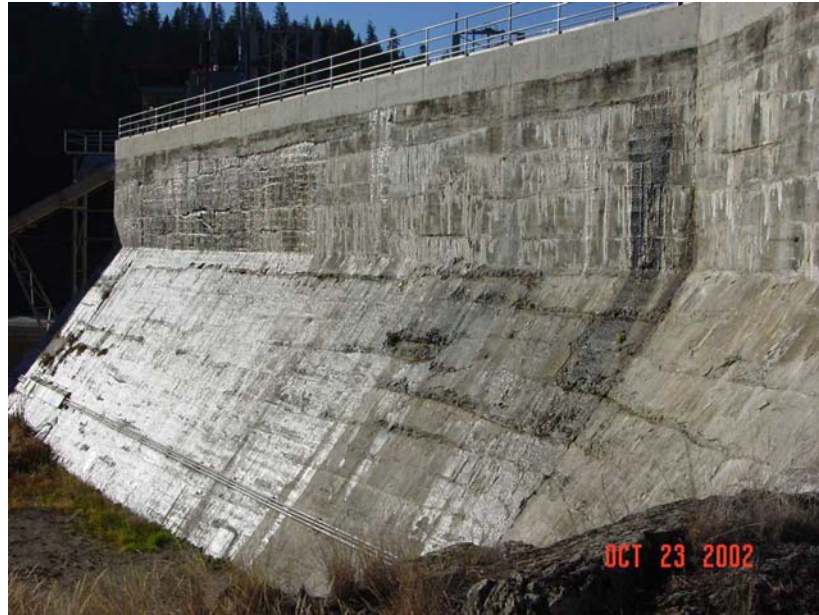
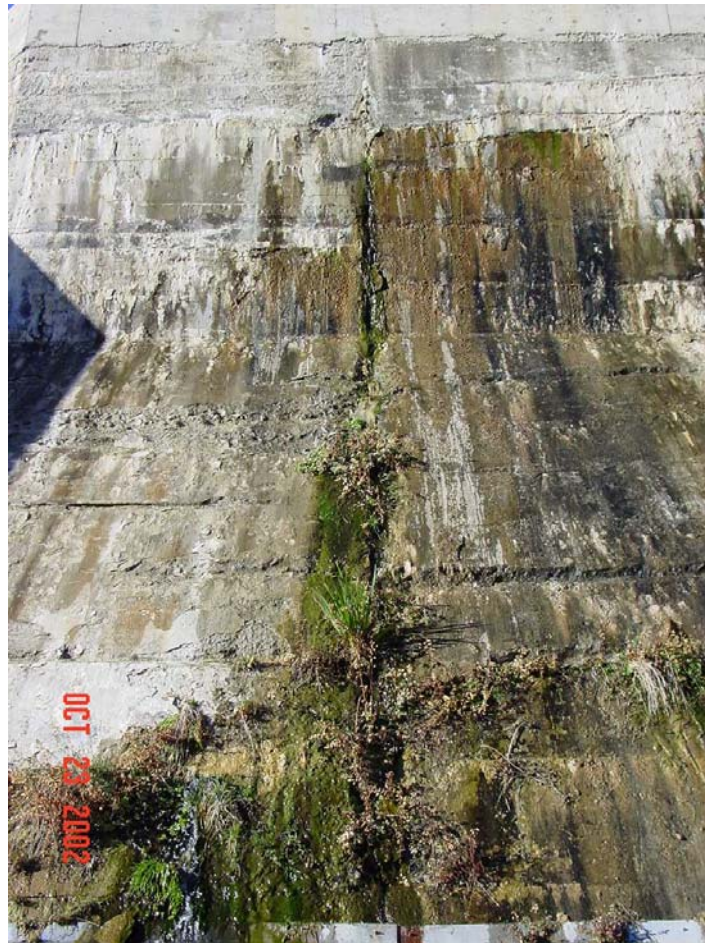
A vertical structure near the SE corner of the intake section appears to be a joint, although attempts to locate the joint detail in the set of plans in the project file were unsuccessful. The "joint" was leaking 5-10 gpm at the time of inspection. In addition, grass and other small vegetation was taking root in the joint-like structure.

Photo 5 & 6 – Corner of Intake and Buttress Sections, (Top)  
Vertical Joint/Crack (Bottom)

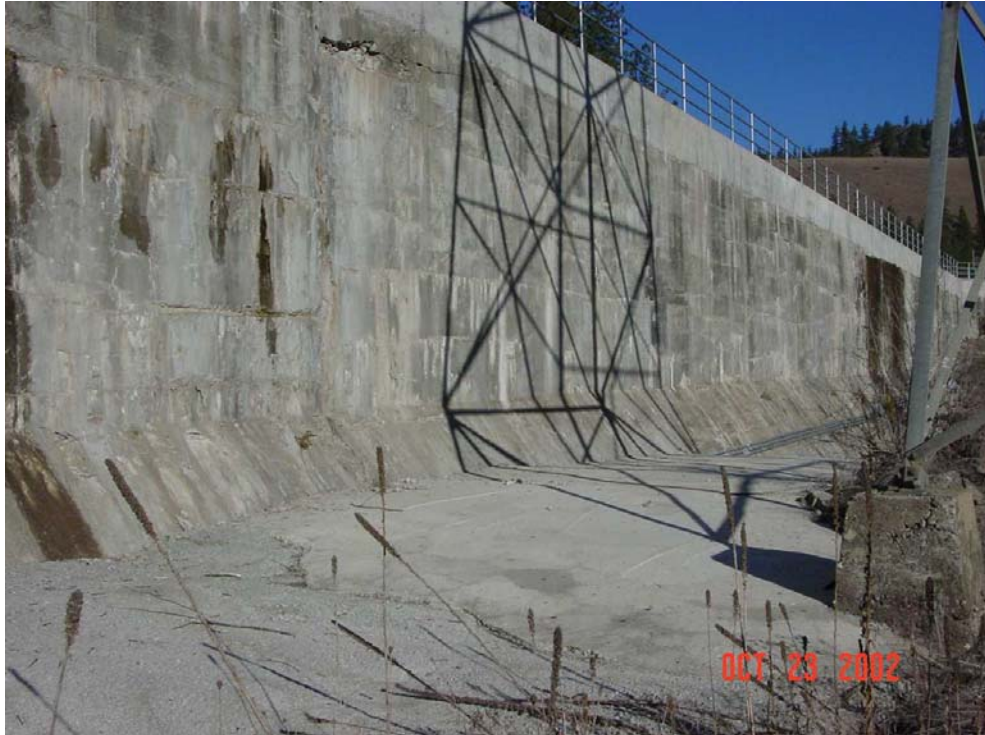
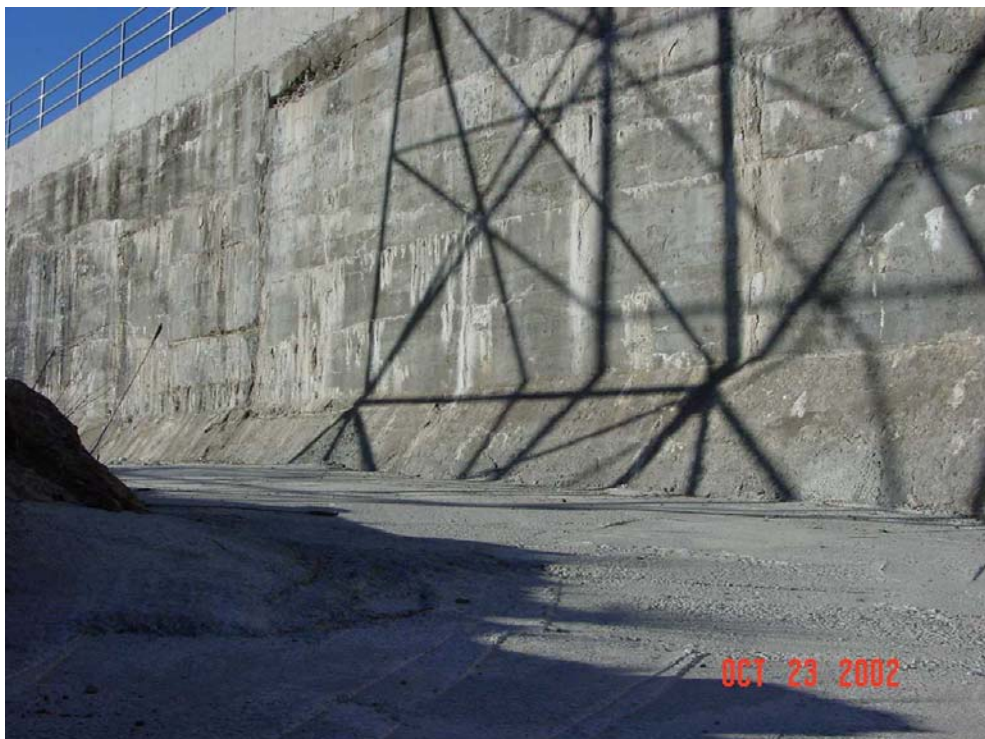
Photo 5 & 6 – Buttress Section (Top)  
Top of Buttress Toe Block (Bottom)

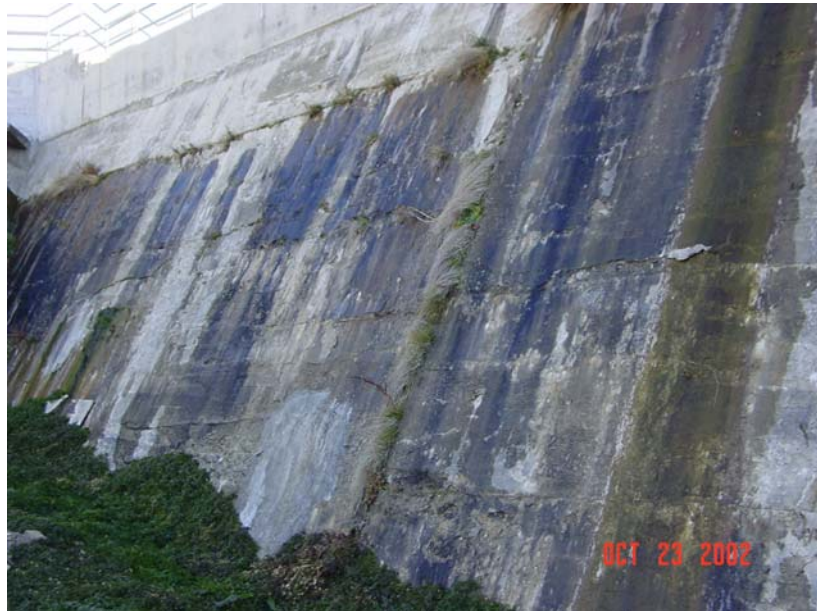
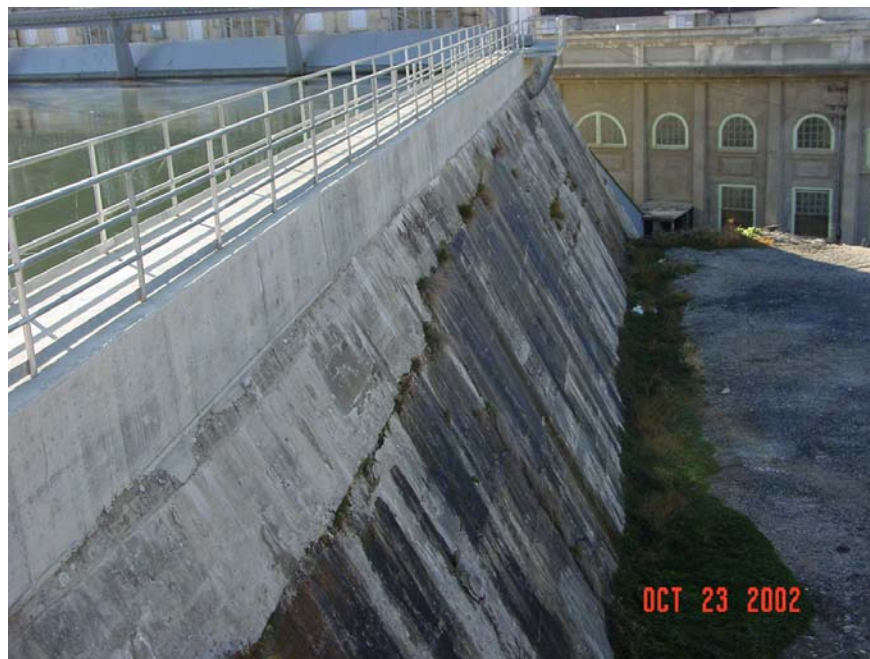
There were no observable signs of structural distress or movement. Any visible damage or irregularity was related to either freeze-thaw action or poor bond at a

Photo 7 & 8 – Downstream Face of Wingwall (Top), Same Area Showing Poor Bond Between Old & New Concrete (Bottom)

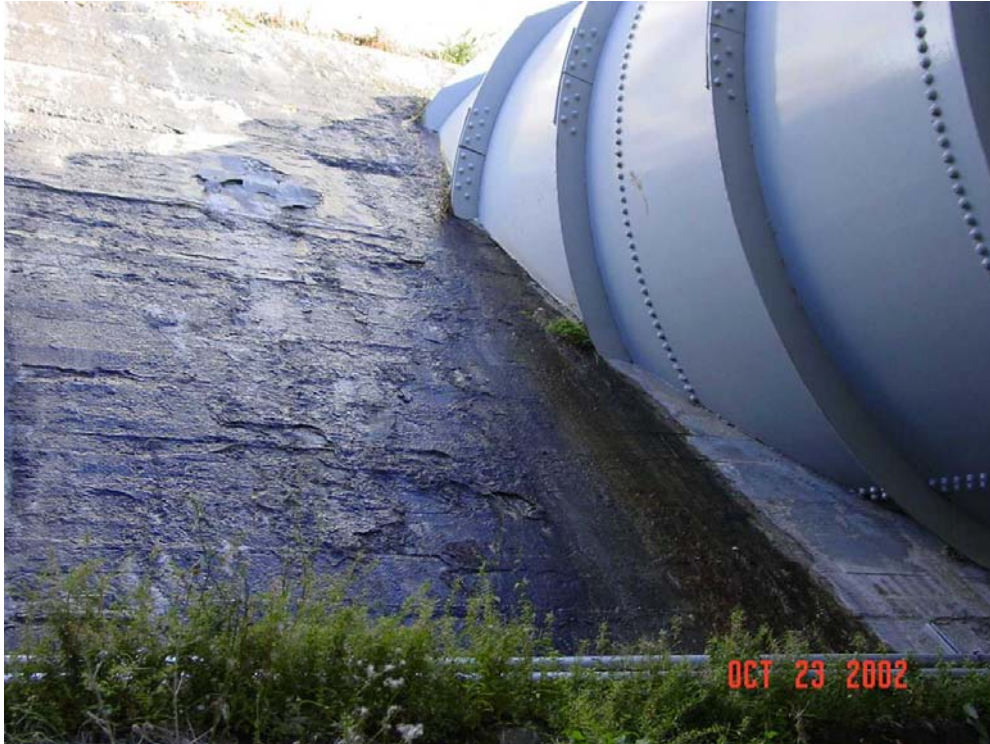
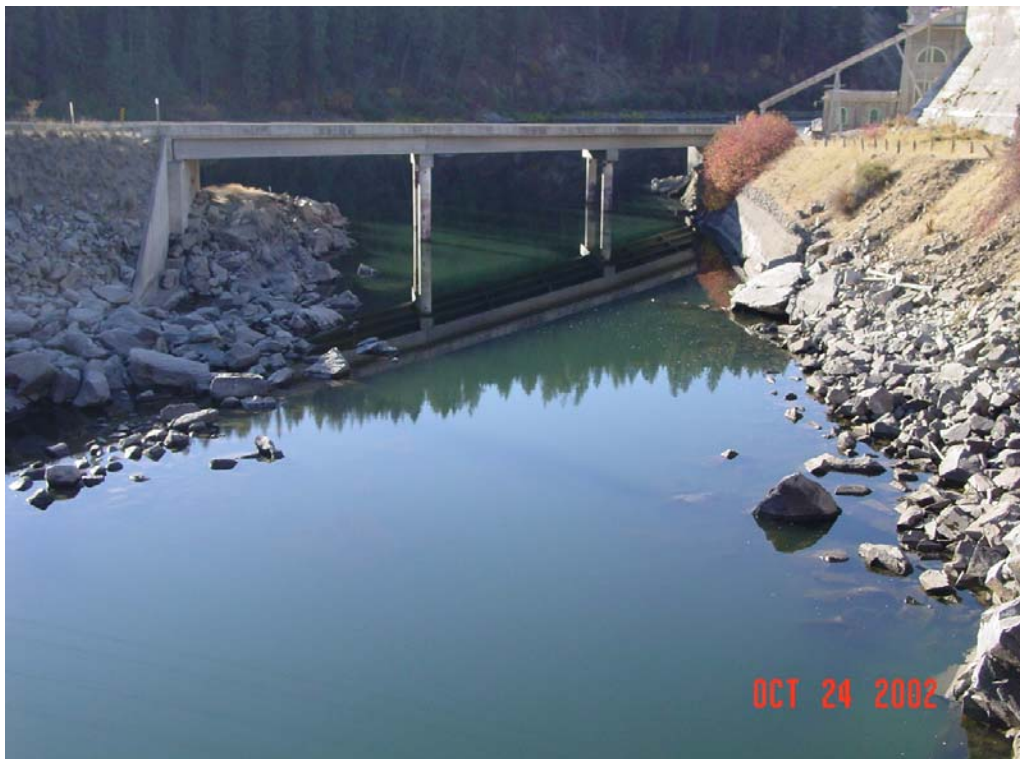
According to the inspection program, the penstocks are inspected every five years. A copy of the Penstock Inspection manual for this project as well as copies of the completed inspection forms from the 2002 inspection are in Appendix D. The inspection forms describe minor amounts of leakage and some small concrete spalls or cracks in surrounding concrete.

Photo 9 & 10 – Penstock Penetration at Intake Section, Leakage (Top),  
Little Falls Rd Bridge, Above are Intake and Buttress Sections (Bottom)
